# **EPA CHEMICAL ACCIDENT INVESTIGATION REPORT**

## **Tosco Avon Refinery Martinez, California**

EPA550-R-98-009  
November 1998

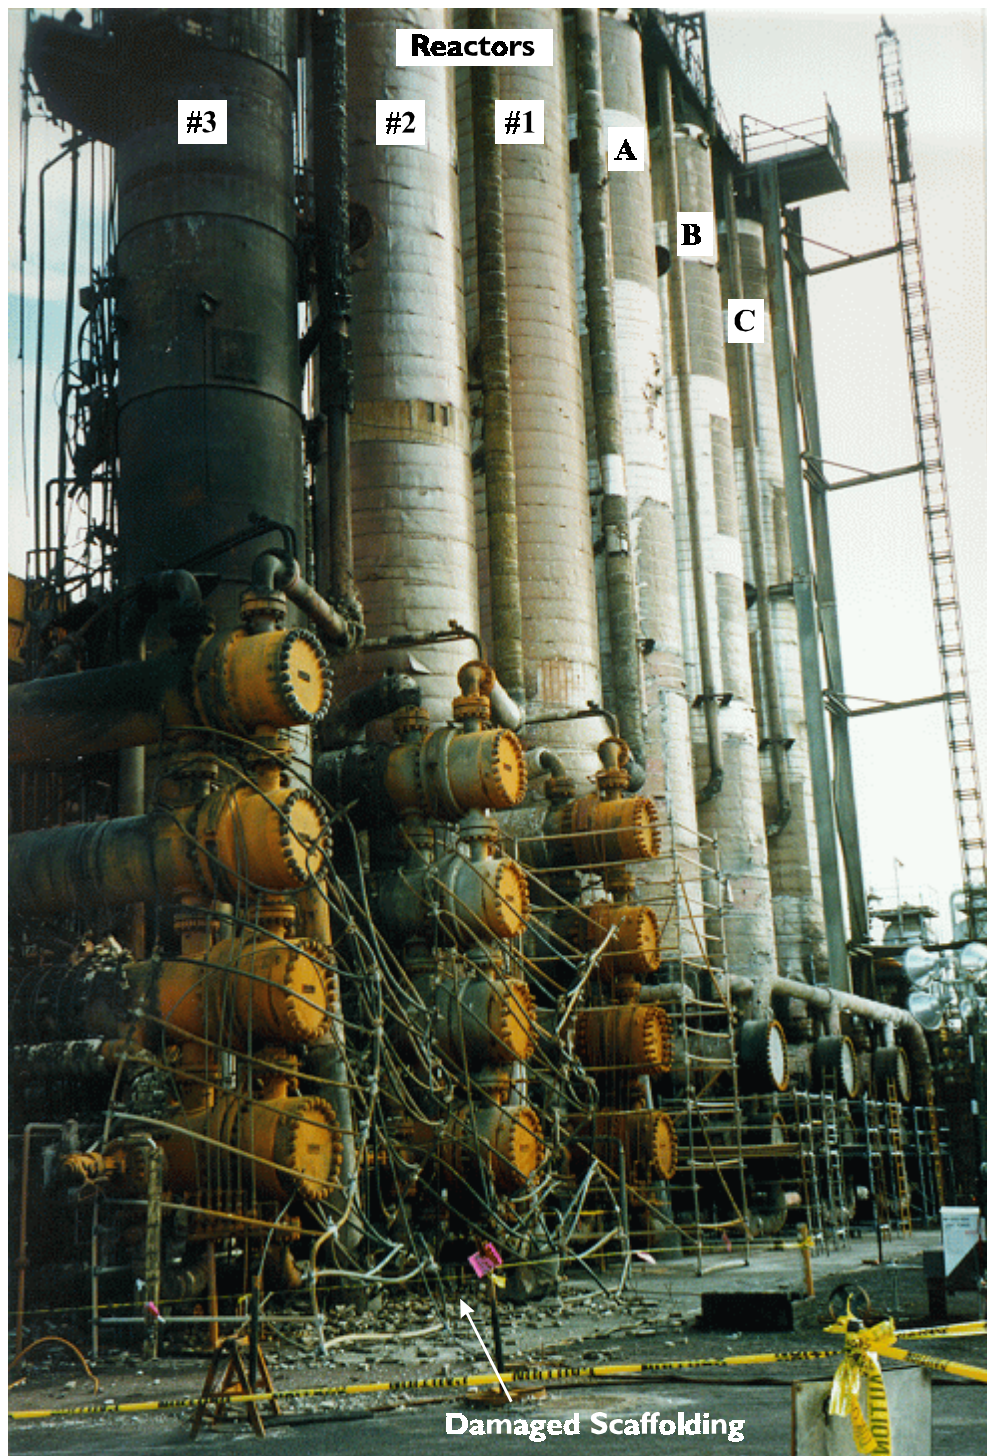
**Figure 9      First and Second Stage Reactors**

The rupture created about an 18 inch long tear in the Reactor 3 effluent piping. The photographs in Figures 9-13 show some of the resulting damage. The fire melted a light pole on the road next to the reactors. The lower part of a metal ladder on Reactor 3 was damaged by the heat. Scaffolding around the Stage 1 and 2 reactors was misshapen from the heat of the fire, but there did not appear to be much blast damage. The fire fighting equipment next to Reactor Road (see Figure 6) was damaged. Wooden platforms near the unit were charred. The six reactors were covered with asbestos insulation overlaid with aluminum, which was blackened by the fire. A large valve on the fire water piping near the road was damaged.

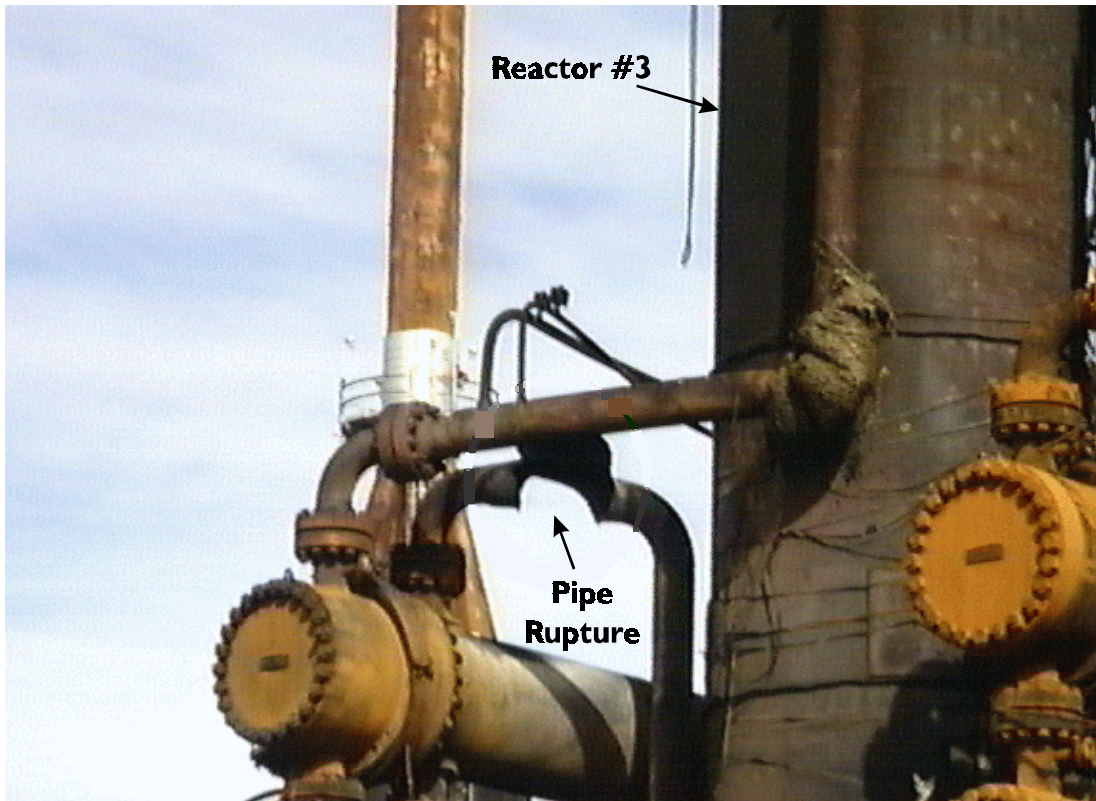
**Figure 10**      **Reactor 3 Effluent Piping Rupture**

Several Tosco and contractor employees reported hearing a pop or crack sound, followed by two explosions, one small and one bigger. A horizontal straight section of 12" diameter Reactor 3 effluent piping had ruptured just upstream of a 12"x 10" diameter reducer. Beyond the reducer, the 10" diameter pipe entered the top of the 40-foot high feed/effluent exchanger structure for Reactor 3. The hydrocarbon and hydrogen mixture released from the pipe rupture apparently autoignited very shortly after the initial release, causing a fireball over 100 feet high.

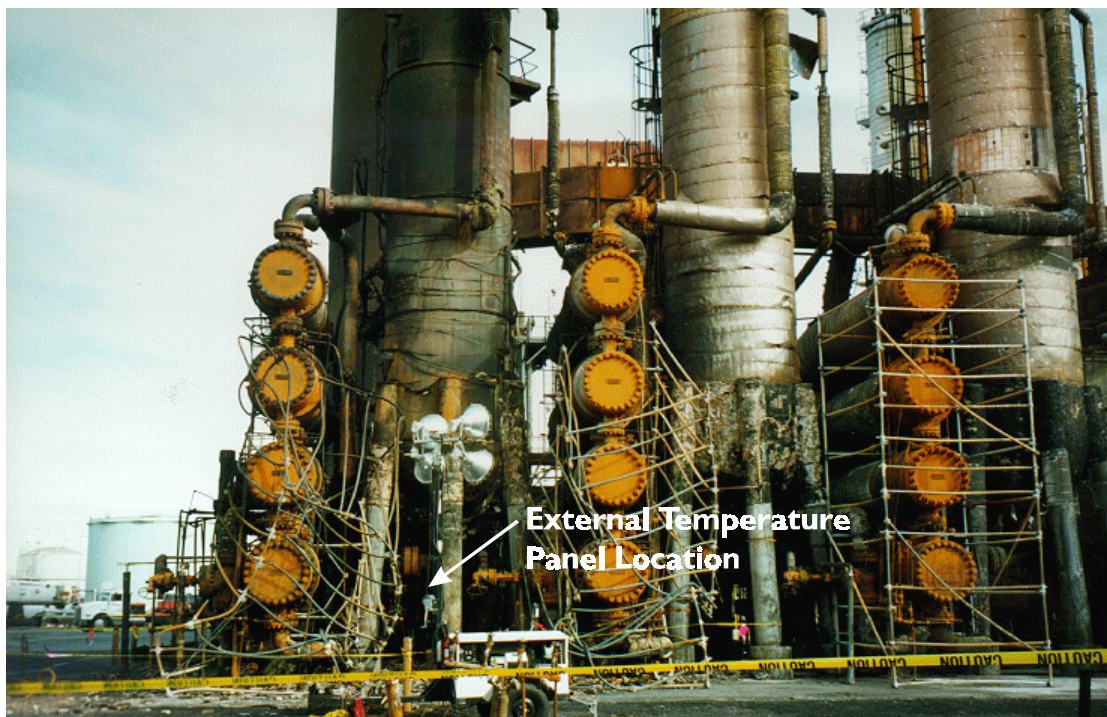
**Figure 11**      **Field Panel Location**

A Tosco Hydrocracker operator, who was in the process of checking the temperature panel located at the base of Reactor 3, was killed. He was severely burned as a result of being in close proximity to the fire from the ruptured pipe. According to the coroner, he died of third-degree burns on 100 percent of his body and smoke inhalation. A total of 46 personnel were injured; eight were Tosco employees and 38 were contractor personnel. Injuries consisted of a fractured foot, emotional trauma, headaches, ringing ears, cuts and scrapes, and twisted knees. Thirteen injured personnel were taken by ambulance to local hospitals, treated and released. There were no reported injuries to the public or other offsite personnel.
